Your Home Inspection Report

*
Drew Finn MA-414
*
www.HIP123.com

Your New Home

File # 12,000
Inspection street 805 Center Street
City/State/Zip Lee, MA 01238
Client name Mickey Mouse
Street address 100 Main Street
City/State/Zip Orlando, FL
Home Phone
Cell phone 100-100-1000
Work phone
Email 1 MM@WDW.com
Email 2 JoeAgent@Flybynight.com
Email 3

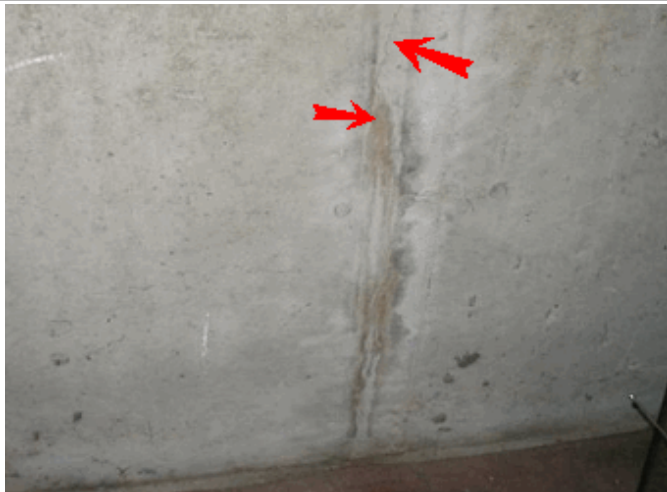
Crack in foundation wall is NOT a structural concern, some water weeps in

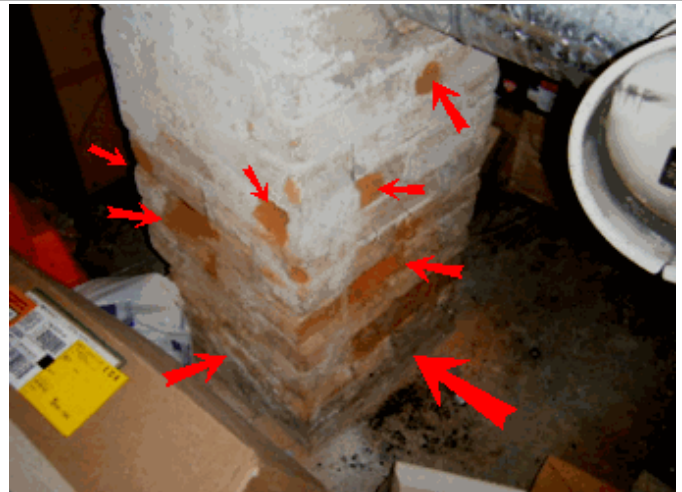
K: Sump pump	SAFETY		K: Cover sump pit for child SAFETY. Motor to sump pump ran. No water was present; unable to verify operability. A second sump pump is recommended, the water that was entering did not run into the sump present.
L: Air moist.	SAFETY		L: Add dehumidifier(s), close windows/vents in basement/crawl spaces during humid weather (dew point above 50 degrees). Conditions exist that promote mold growth (elevated levels of moisture in the air).
M: Bsmt. entry	UNSAT		M: Basement exterior entry doors do not seal effectively to the outside, replace the doors.
N: Other	UNSAT		N: The original chimney bricks are deteriorated in the basement; replace as needed.

Bricks at bottom of original chimney are deteriorated; rebuild

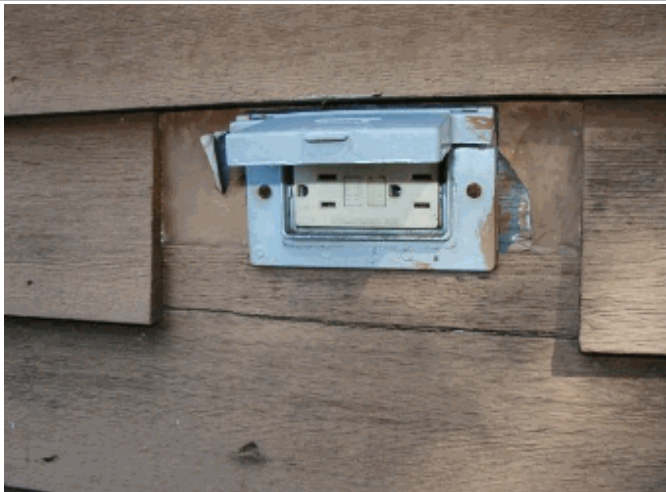
GFCI receptacle above deck does not trip off, and wood trim missing around cover

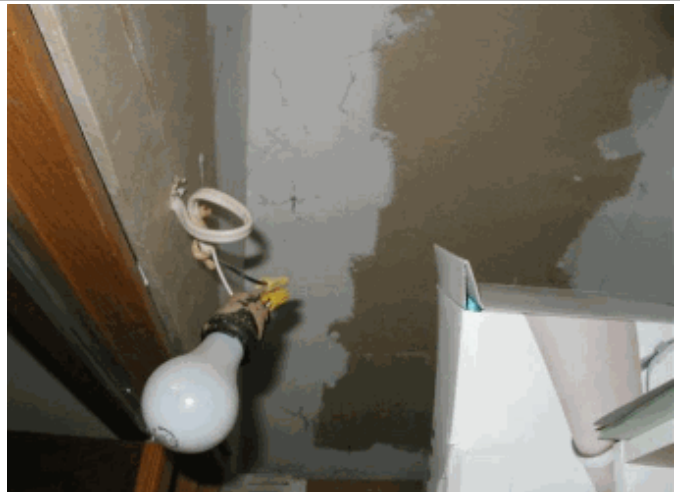
Bedroom closet has unsafe light, is a fire hazard, install pertinent fluorescent light

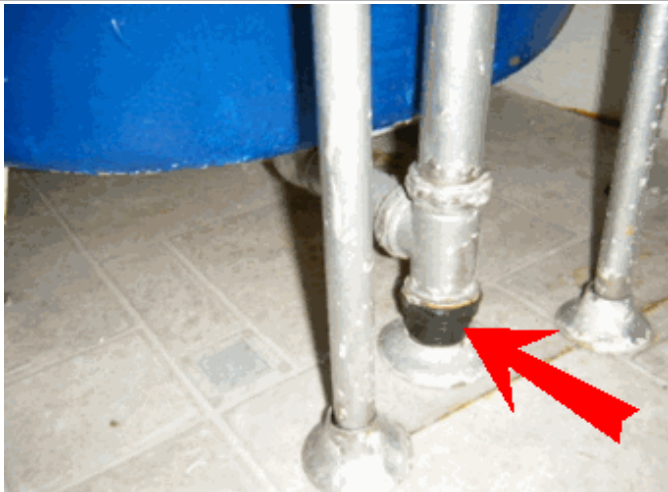
Tape on drain pipe at floor; correct, may need to cut open the floor

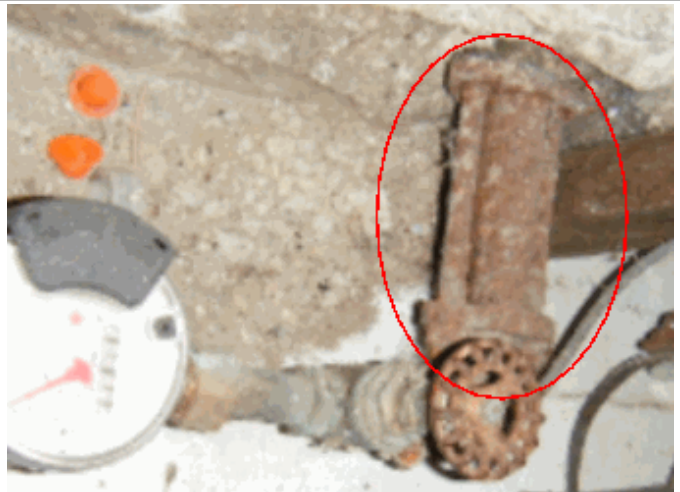
Old iron pipe water entry into the house, could need replacement at any time

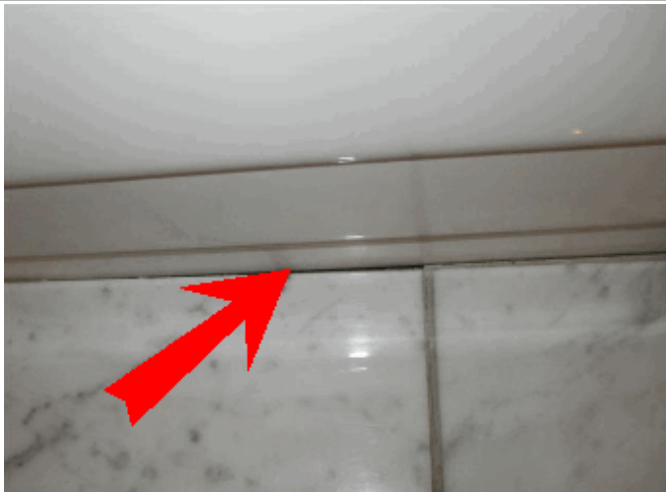
Seal between tiles and tub/showers

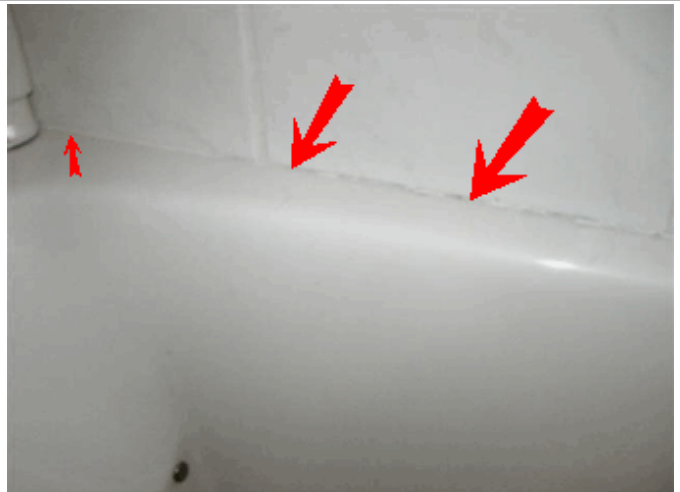
Seal between jet tub and walls

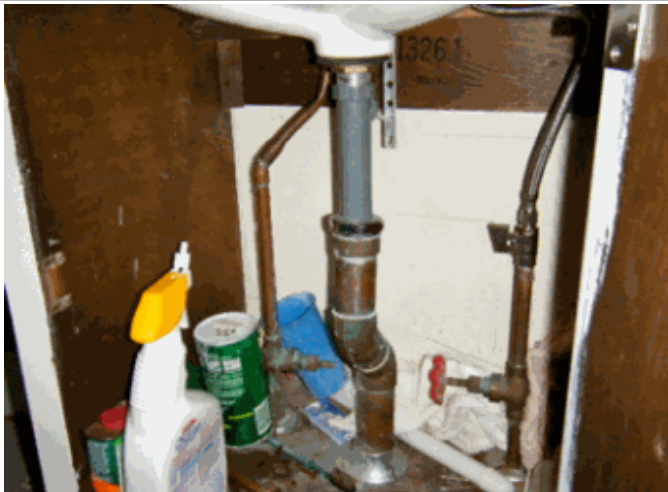
A: Bath Location		OK	A: This was the 1/2 bath located in the basement.
B: Tub/shower		N/A	B:
C: Sink	SAFETY		C: No apparent gas trap below the sink; have a plumber evaluate to see is a trap is below the floor, likely is not, add a trap.
D: Toilet		OK	D:
E: Ventilation		OK	E:
F: Water flow		OK	F:
G: Drainage		OK	G:
H: Floor		OK	H:
I: Bath Location		N/A	I: no 4th bath
J: Tub/shower			J:
K: Sink			K:
L: Toilet			L:
M: Ventilation			M:
N: Water flow			N:
O: Drainage			O:
P: Floor			P:

No apparent trap; have plumber evaluate and correct as needed.

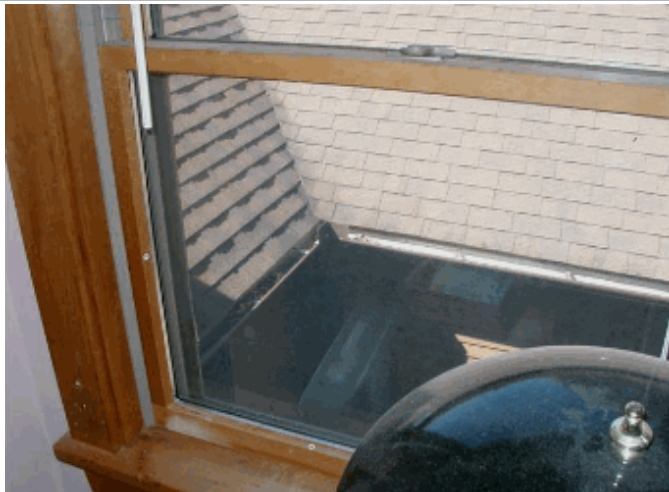
Glass is fogged, replace glass to make clear

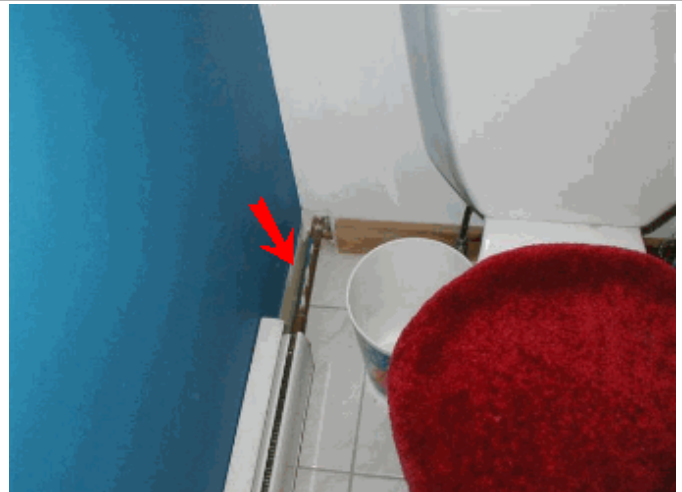
Trim missing in many areas and radiator cover missing too

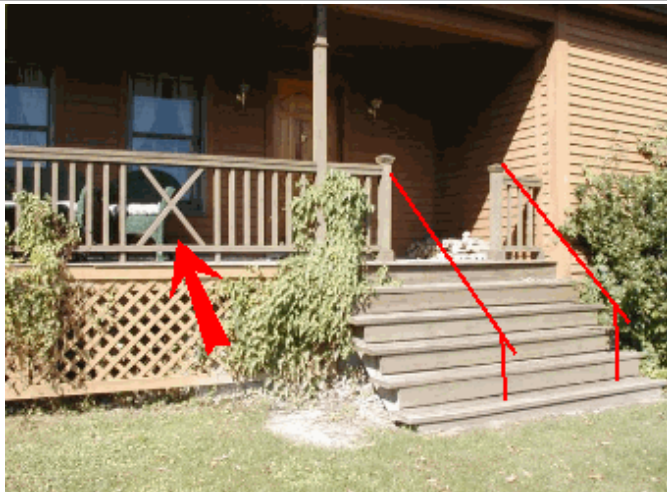
Add handrails along steps and openings below handrail too large in areas

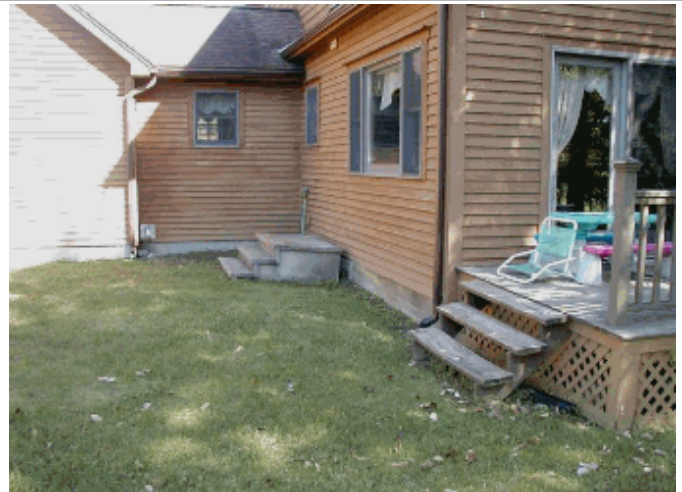
Remove concrete steps and correct yard drainage to shed water away

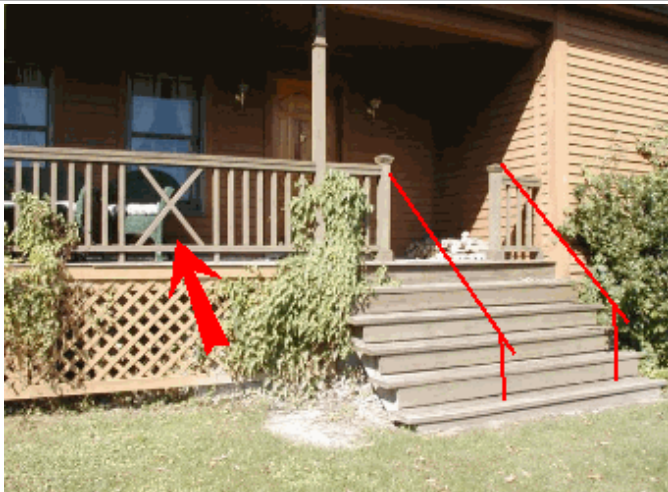
Add handrails along steps and openings below handrail too large in areas

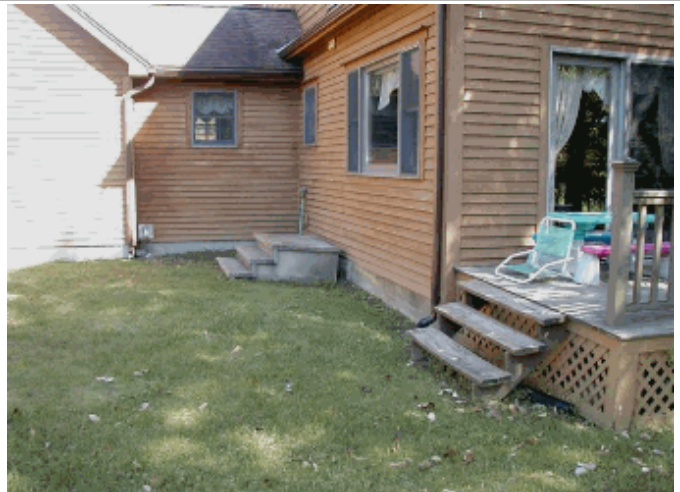
Remove concrete steps and correct yard drainage to shed water away

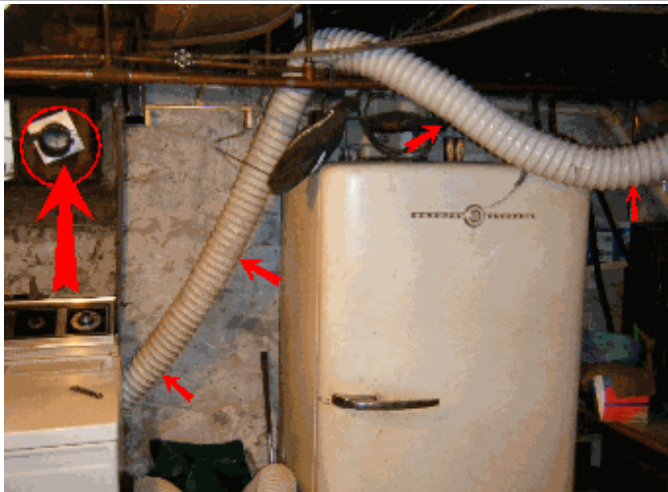
Replace dryer vent with a metal pipe and vent to the outside

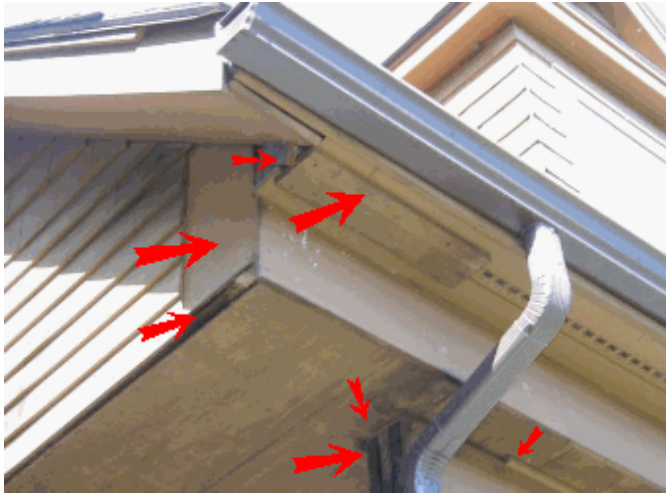
Exterior: Missing molding outside

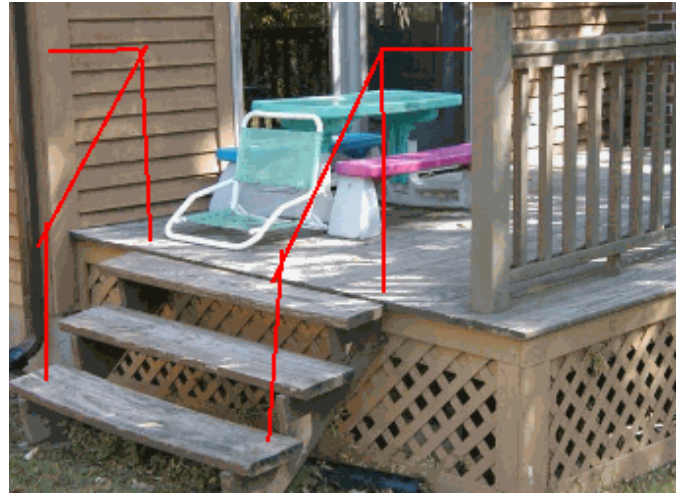
Exterior: Replace back deck steps and extend handrails for SAFETY

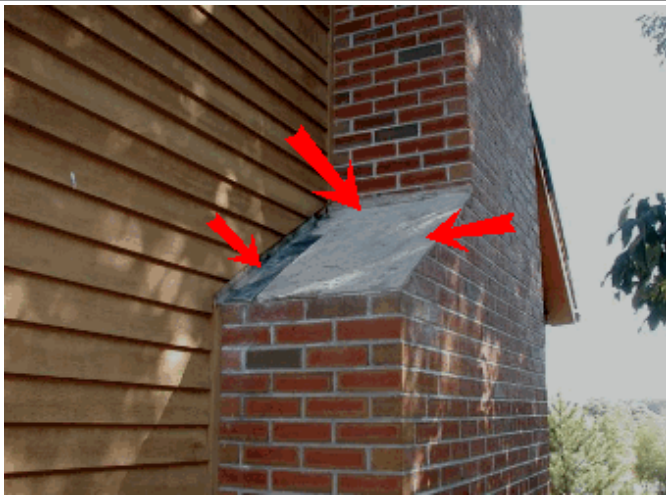
Exterior: Flag stone missing from chimney

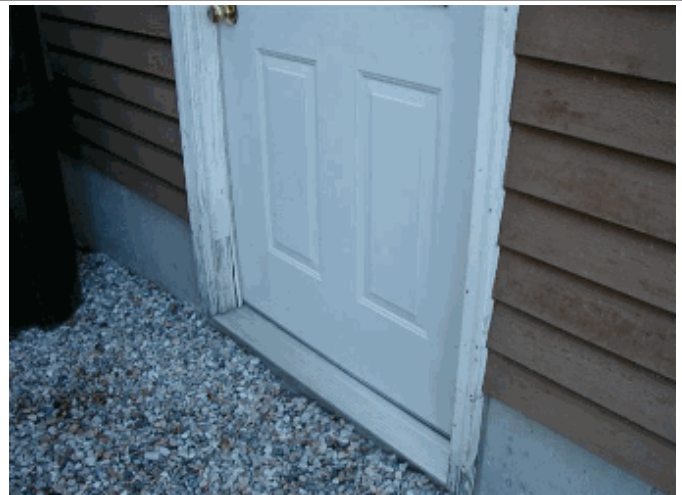
Exterior: Paint trim on garage door to avoid wood rot

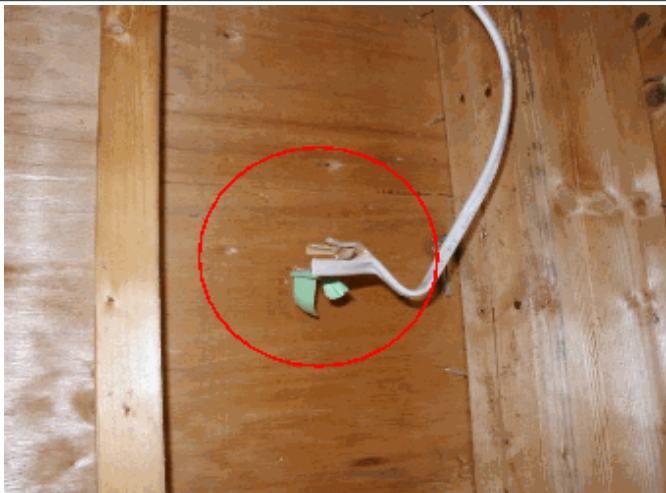
Elect.: Terminate free end wires in boxes, this one in garage one under window in bedr

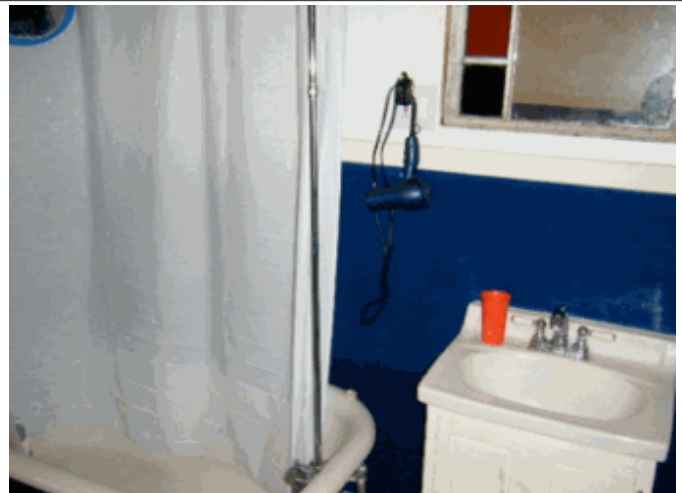
Elect.: Light switch and receptacle reachable from the tub; relocate for Safet
